# Manhole Inspection Summary

Manhole # S25CC1025MH

**Location** Address: **1027 UNION AVE**

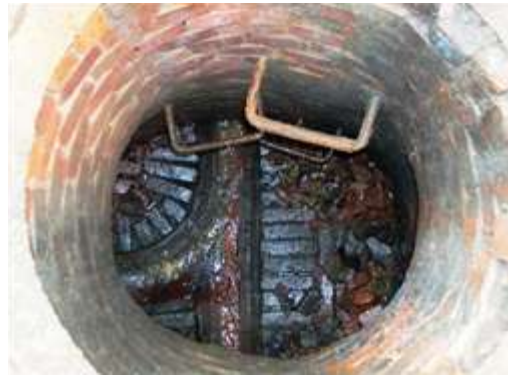
Top View

Corroded steps. Bench debris.

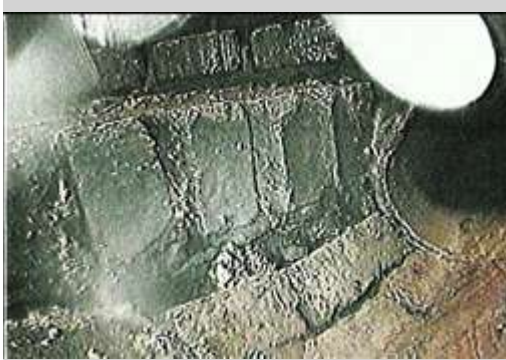
Defect

Bench and Channel deterioration.

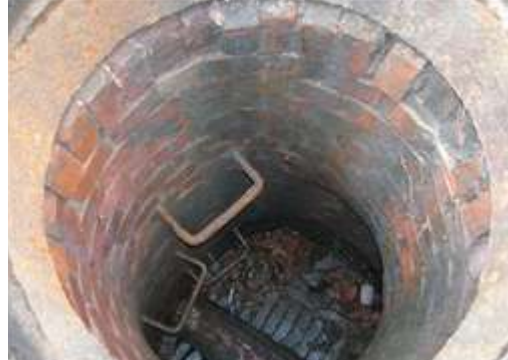
Defect

Frame leaks. Adjustment deterioration, loose brick, root intrusion and infiltration. Barrel infiltration

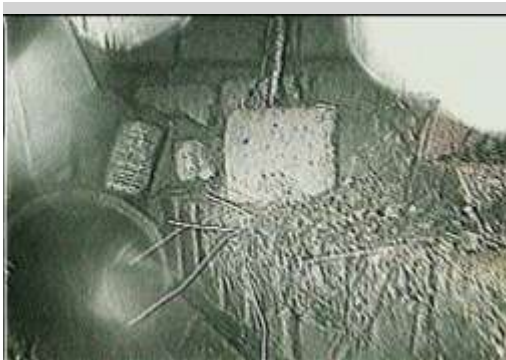
Defect

Bench and Channel root intrusion.

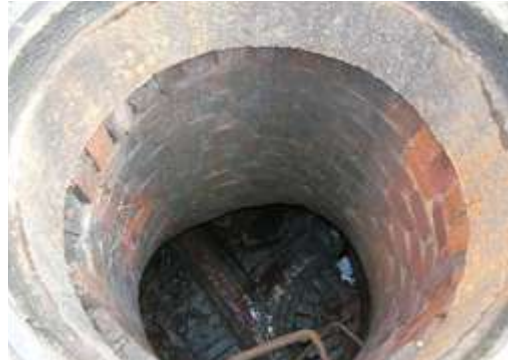
Defect

Frame leaks. Adjustment deterioration, loose brick, root intrusion and infiltration. Barrel infiltration - other side.

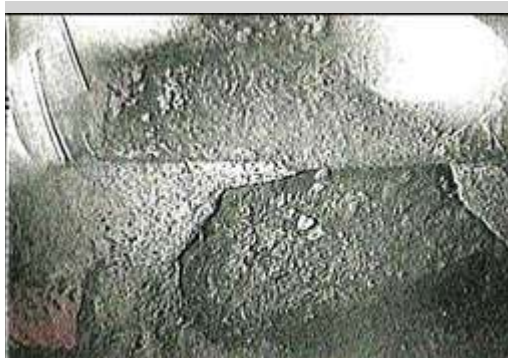
Defect

Comments **There is a large hole in the Corbel.**

Hole in Corbel.

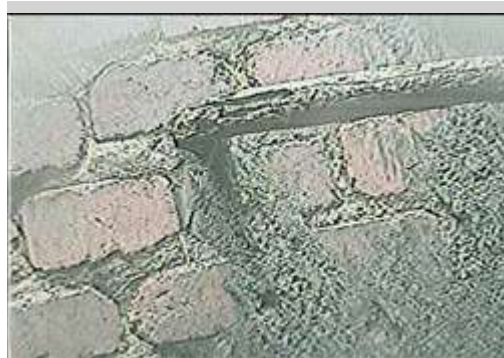
Defect

Corbel deterioration and infiltration.

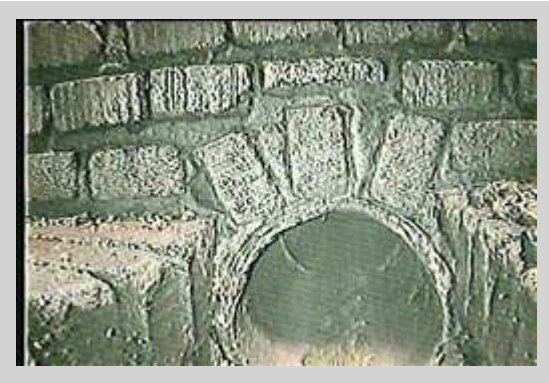
### 8 in. Circular Gravity Sewer Pipe Out @ 12 O'Clock

Barrel deterioration, root intrusion and infiltration. Bench and Channel deterioration.

Infiltration: **Evidence** Pipe Seal Cond: **Roots**

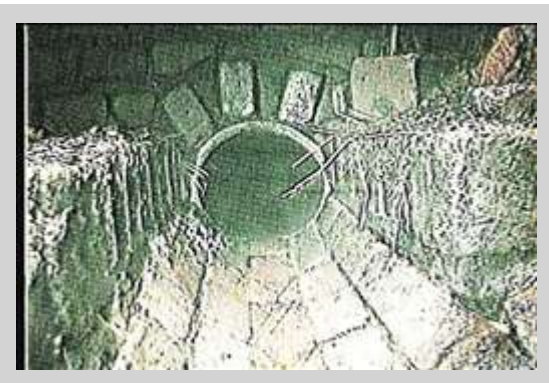
### 8 in. Circular Gravity Sewer Pipe In @ 6 O'Clock

Infiltration: **Evidence** Pipe Seal Cond: **Unknown**

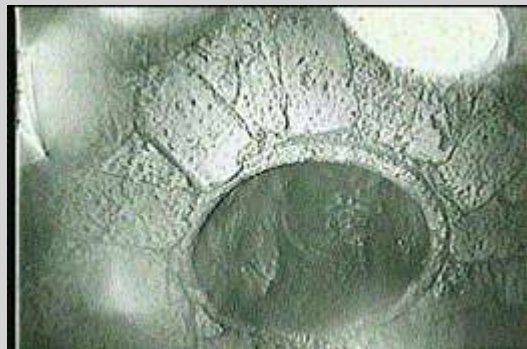
Pipe In @ 9 O'Clock

Barrel deterioration, root intrusion and infiltration. Channel deterioration.

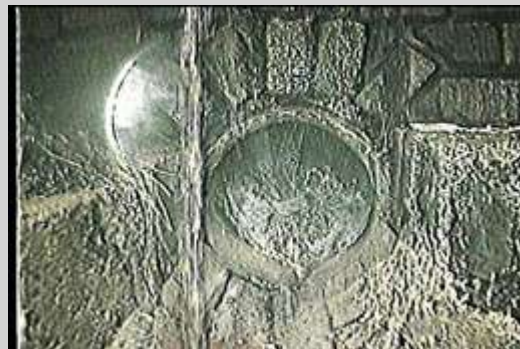
Drop In @ 9 O'Clock

Drop Condition: **Partly Clogged**
